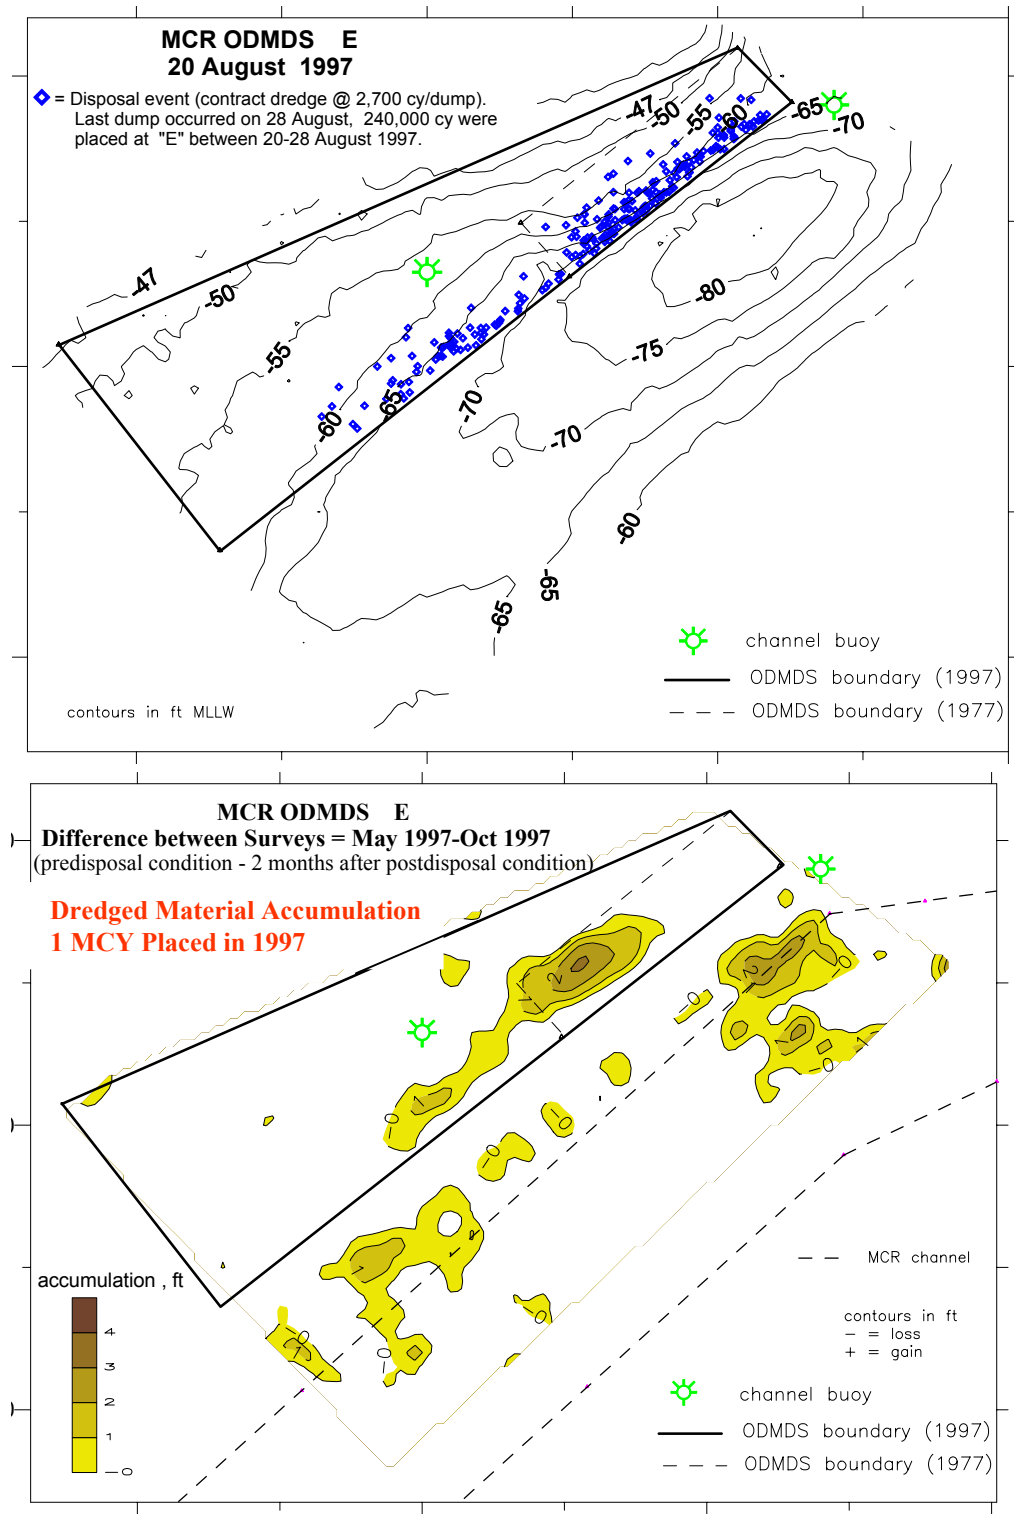
Figure D1. ODMDS E (shallow water ODMDS) was expanded in 1997. Top graph shows bathymetry of ODMDS E at end of 1997 dredging season with locations of dredged material placement; note limited area over which dredged material was placed in 1997. Bottom graph shows the accumulation of dredged material on the seabed within ODMDS E (due to dredged material placement) and deposition of sediment along the northern perimeter of the MCR navigation channel due to natural processes. At the end of the dredging season, the maximum accumulation of placed dredged material within ODMDS E was 3 ft.
